FINAL CLOSEOUT REPORT FOR  
117-F FILTER BUILDING

UNI-2692

November 30, 1983

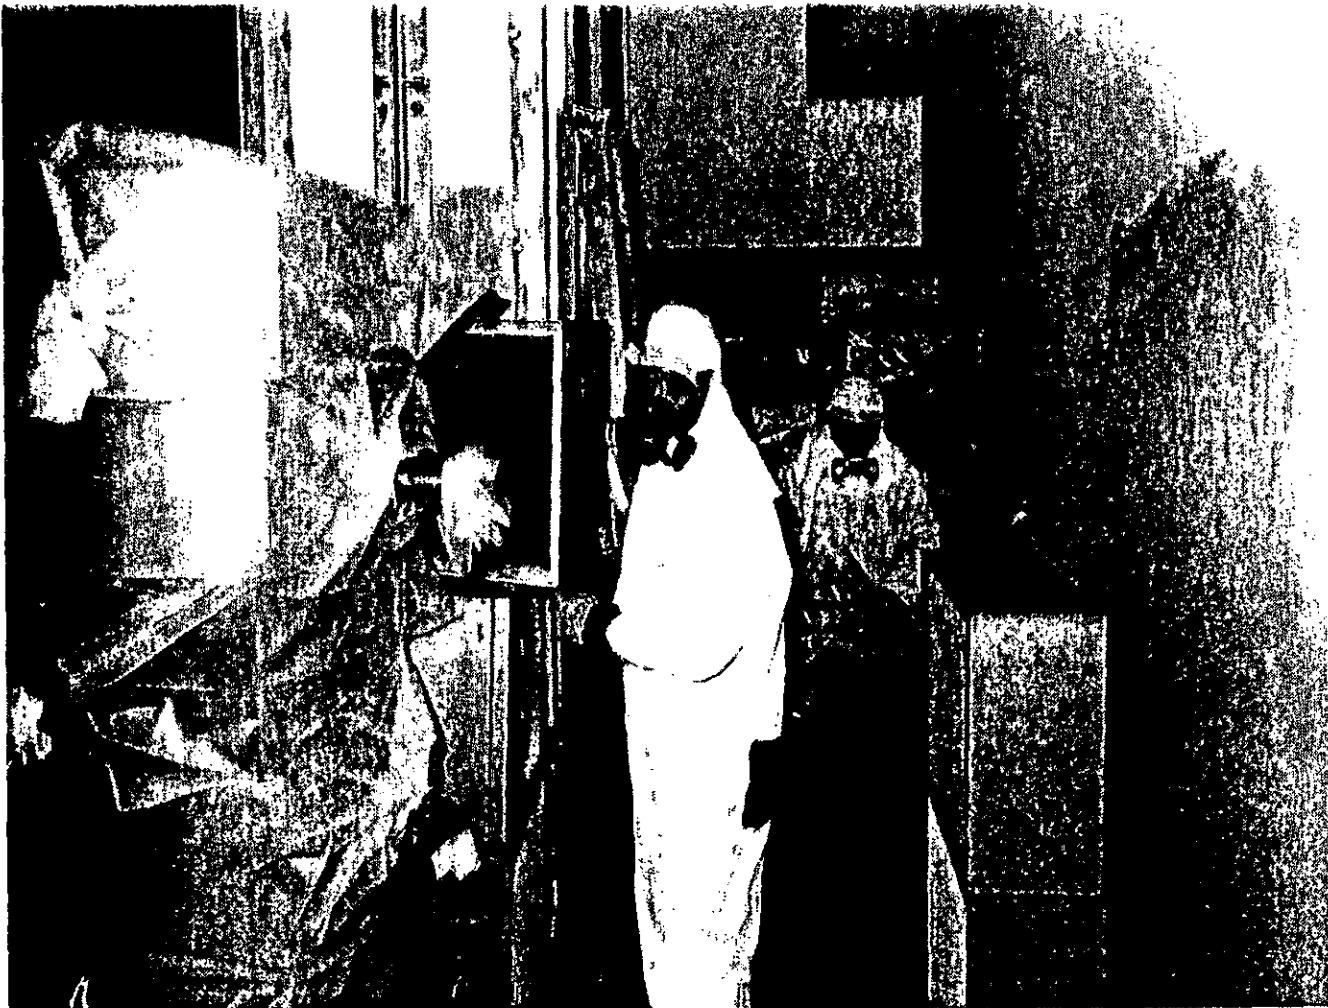
FIGURE 3.1  
REMOVING HEPA FILTER  
117-F FILTER BUILDING

1. Dust was vacuum cleaned from the floors and walls to prevent any loose contamination from spreading to noncontaminated areas.
2. All remaining filters in both the particulate and charcoal filter banks were unbolted and removed from their holding frames and placed in plastic bags, which were sealed with tape. (See Figures 3.1 and 3.2.)

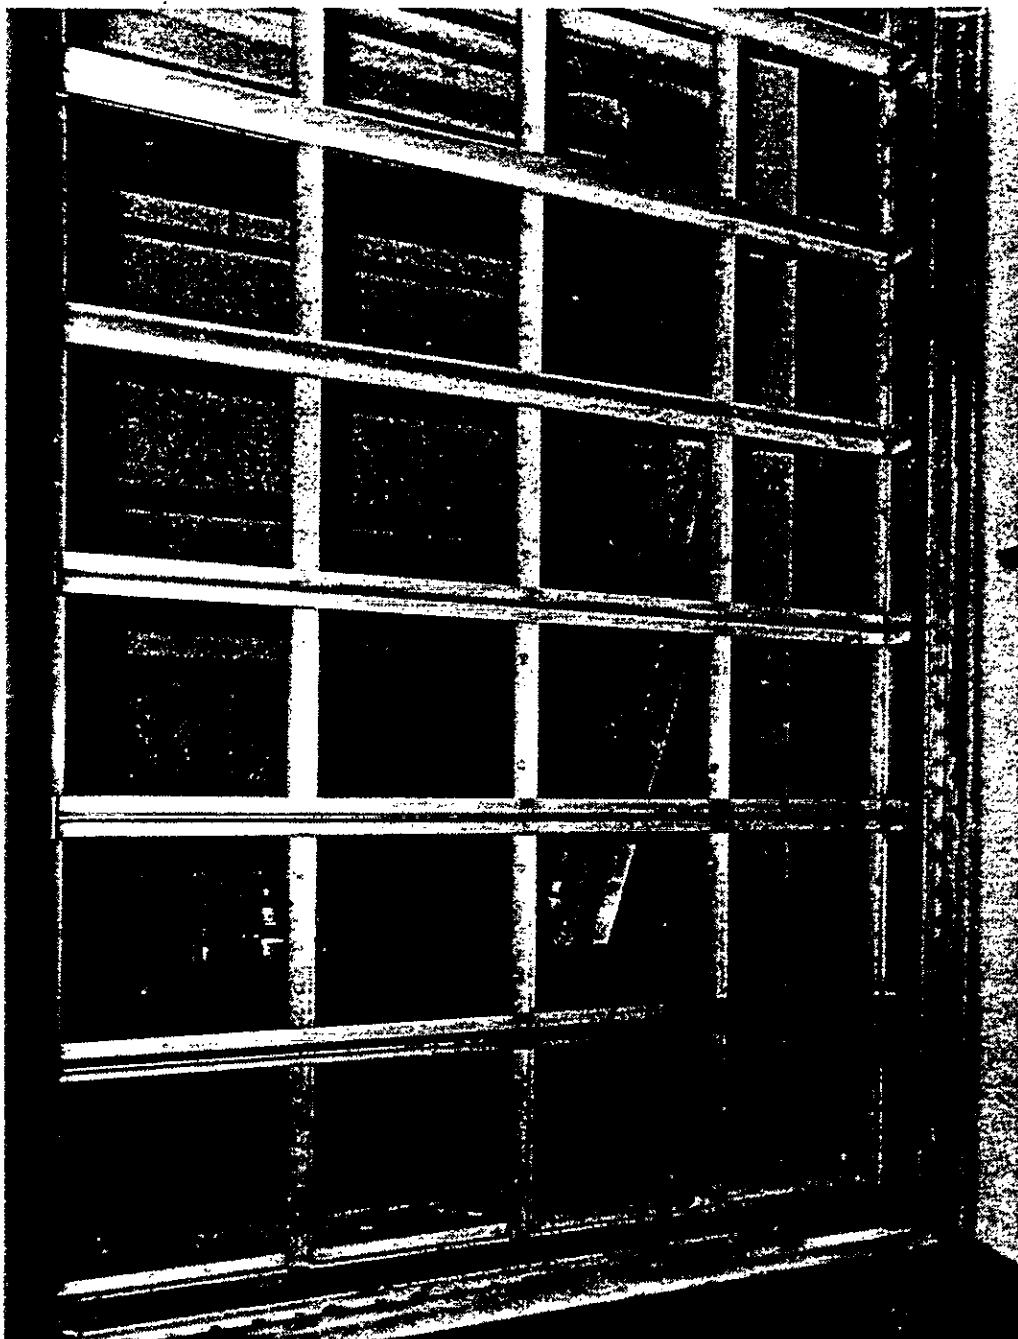
FIGURE 3.4  
FILTER FRAMES AND DECK GRATING

brushing and other techniques. The drains were verified to be uncontaminated. All deck gratings (Figure 3.4) were left in place after decontamination, as an industrial safety precaution.

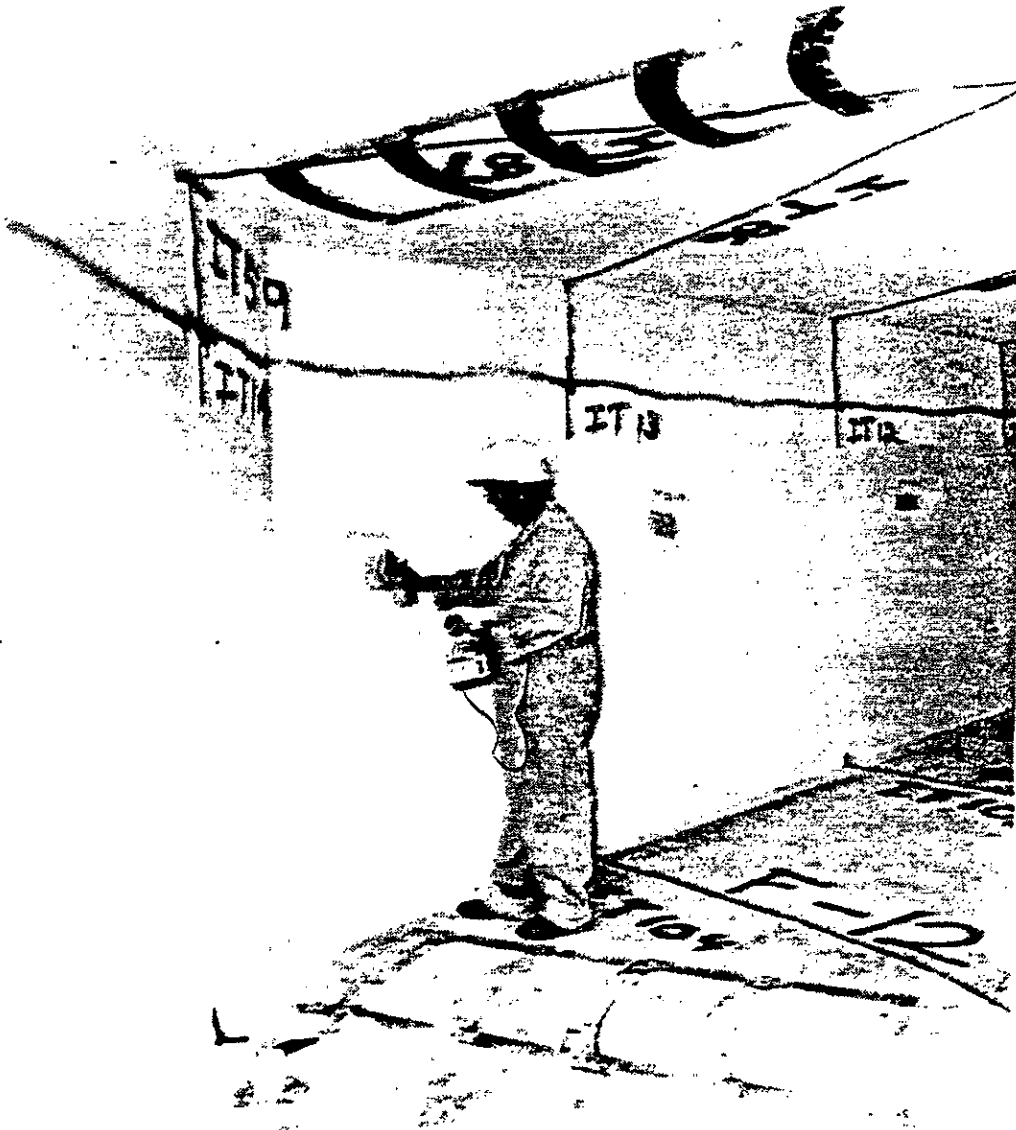
FIGURE 3.5  
TAKING SMEAR SAMPLES

1. Dust was vacuum cleaned from the internal duct surfaces to prevent any loose contamination from spreading to noncontaminated areas.
2. All internal equipment such as turning vanes and sampling and detection piping were removed. Noncontaminated equipment and successfully decontaminated equipment were buried on the building site as clean waste.
3. Contaminated equipment was wrapped, packaged, and shipped to the 200 West Area for burial in compliance with Reference 10.
4. All inside surfaces were wiped clean of any loose dust and marked off in 2m x 2m grids (Figures 3.5 and 3.6). Surface smears were taken in each grid and labeled. Paint samples were taken from each grid and labeled. Smears and paint samples were analyzed for radioactive contamination.

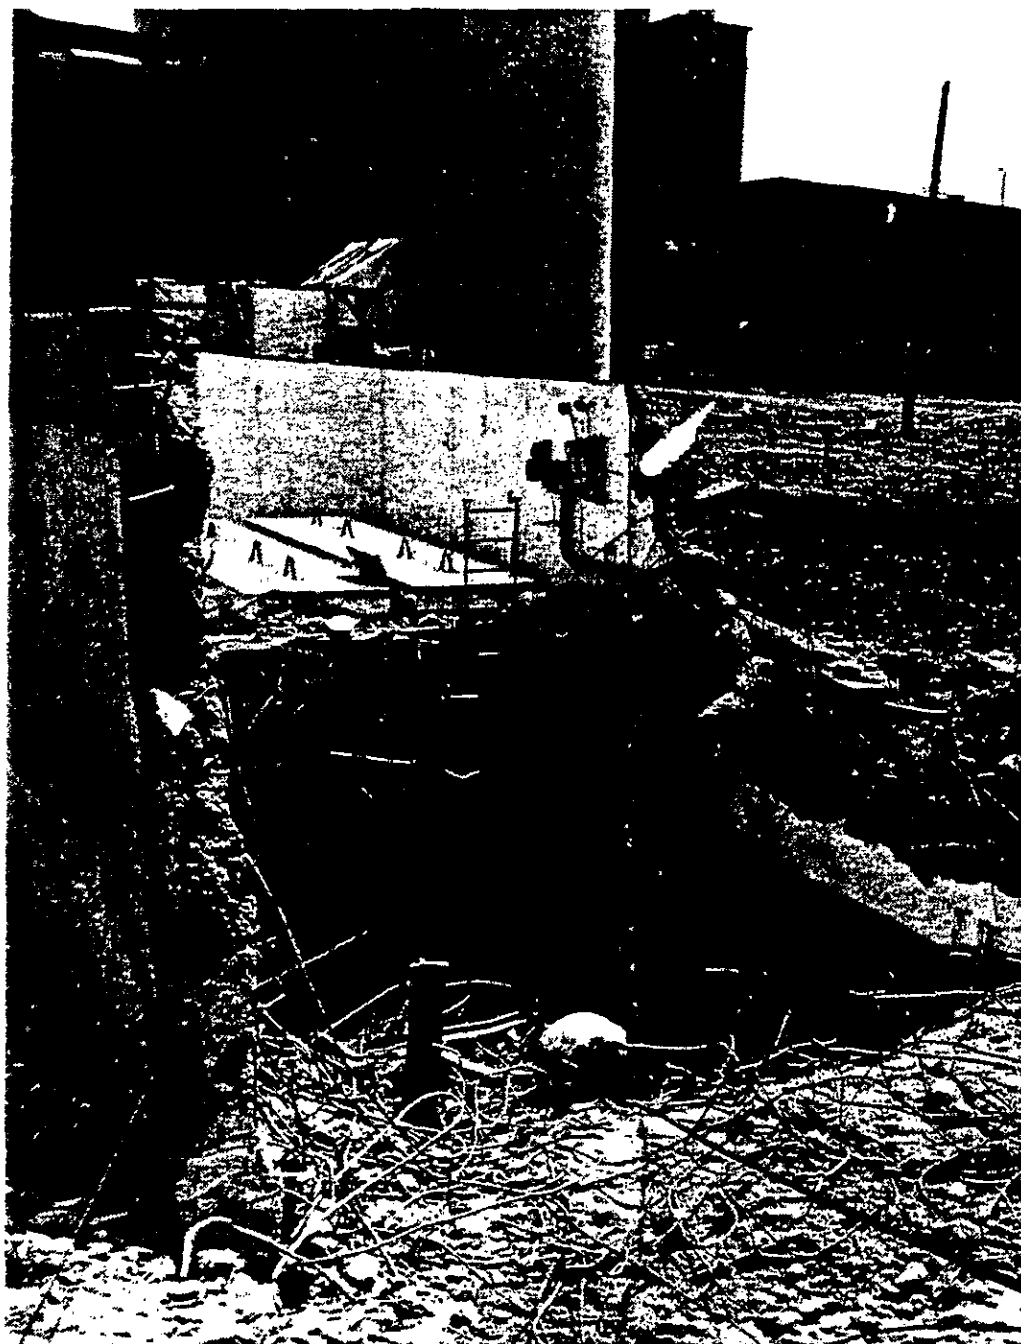
FIGURE 4.1  
DEMOLITION OF 117-F WITH THE USE OF CRANE AND DEMOLITION BALL

Demolition of the 117-F building and ducts was accomplished by conventional means, using a crane, demolition ball, and bulldozer. See Figures 4.1, 4.2, and 4.3. At completion of the demolition, the site (Figure 4.4) was backfilled with 615 yd<sup>3</sup> of clean soil and graded to blend with the natural terrain. Revegetation will be by natural seeding of indigenous growth.
